EGG-TMI-8020
April 1988

ASSESSMENT OF TMI-2 PLENUM ASSEMBLY DAMAGE

EG&G Idaho, Inc.
Idaho Falls, Idaho 83415

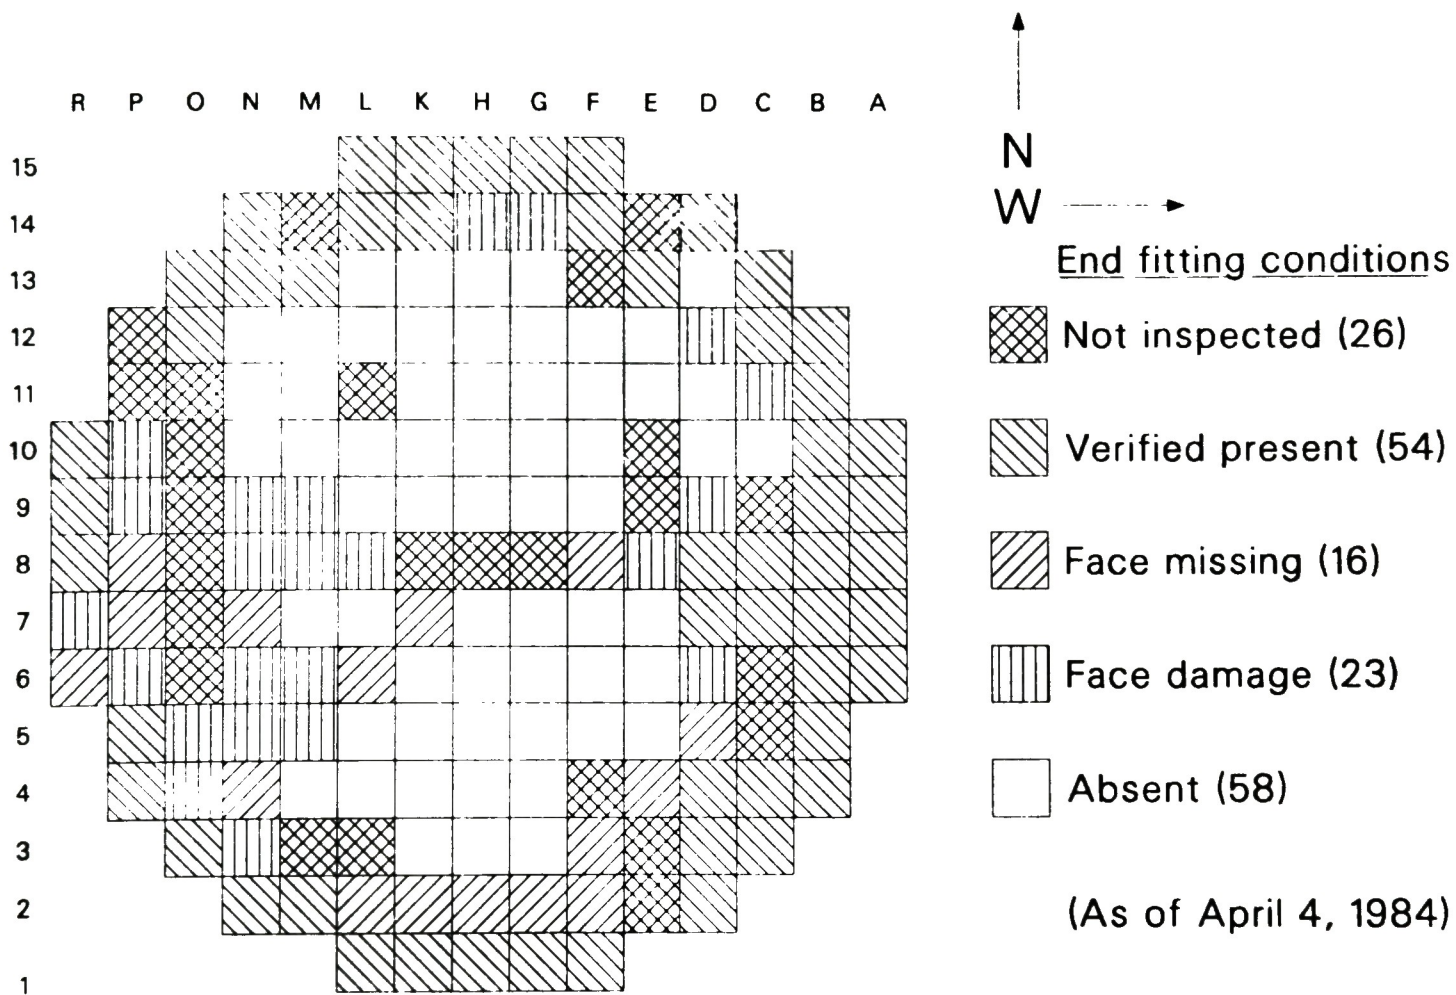
P556 PUI-288-04

The earliest observation of the damage to the plenum assembly was made in April 1984, with a video camera lowered through the H8 (core center) control rod guide assembly after the leadscrew had been removed. Except for the standing peripheral assemblies, a void existed in the upper part of the core where the rod bundles had disintegrated into a rubble bed. The existence of the void enabled the camera to swing laterally to obtain a panoramic view of the conditions on the underside of the plenum assembly. The results are graphically depicted in Figure 8.⁶ Above the void, there were a large number of upper end fittings still attached to the underside of the plenum assembly, some partially damaged, some still intact. Where the end fittings were missing, partial damage and some melting of the upper grid were observed. So, it is likely that the missing end fittings had stuck to, or at, the upper grid but were later melted away. Due to the limited viewing angle, the full extent of the damage to the underside of the plenum assembly was not obtained.

Figure 8. Damage conditions on the underside of the plenum assembly as observed in April 1984.

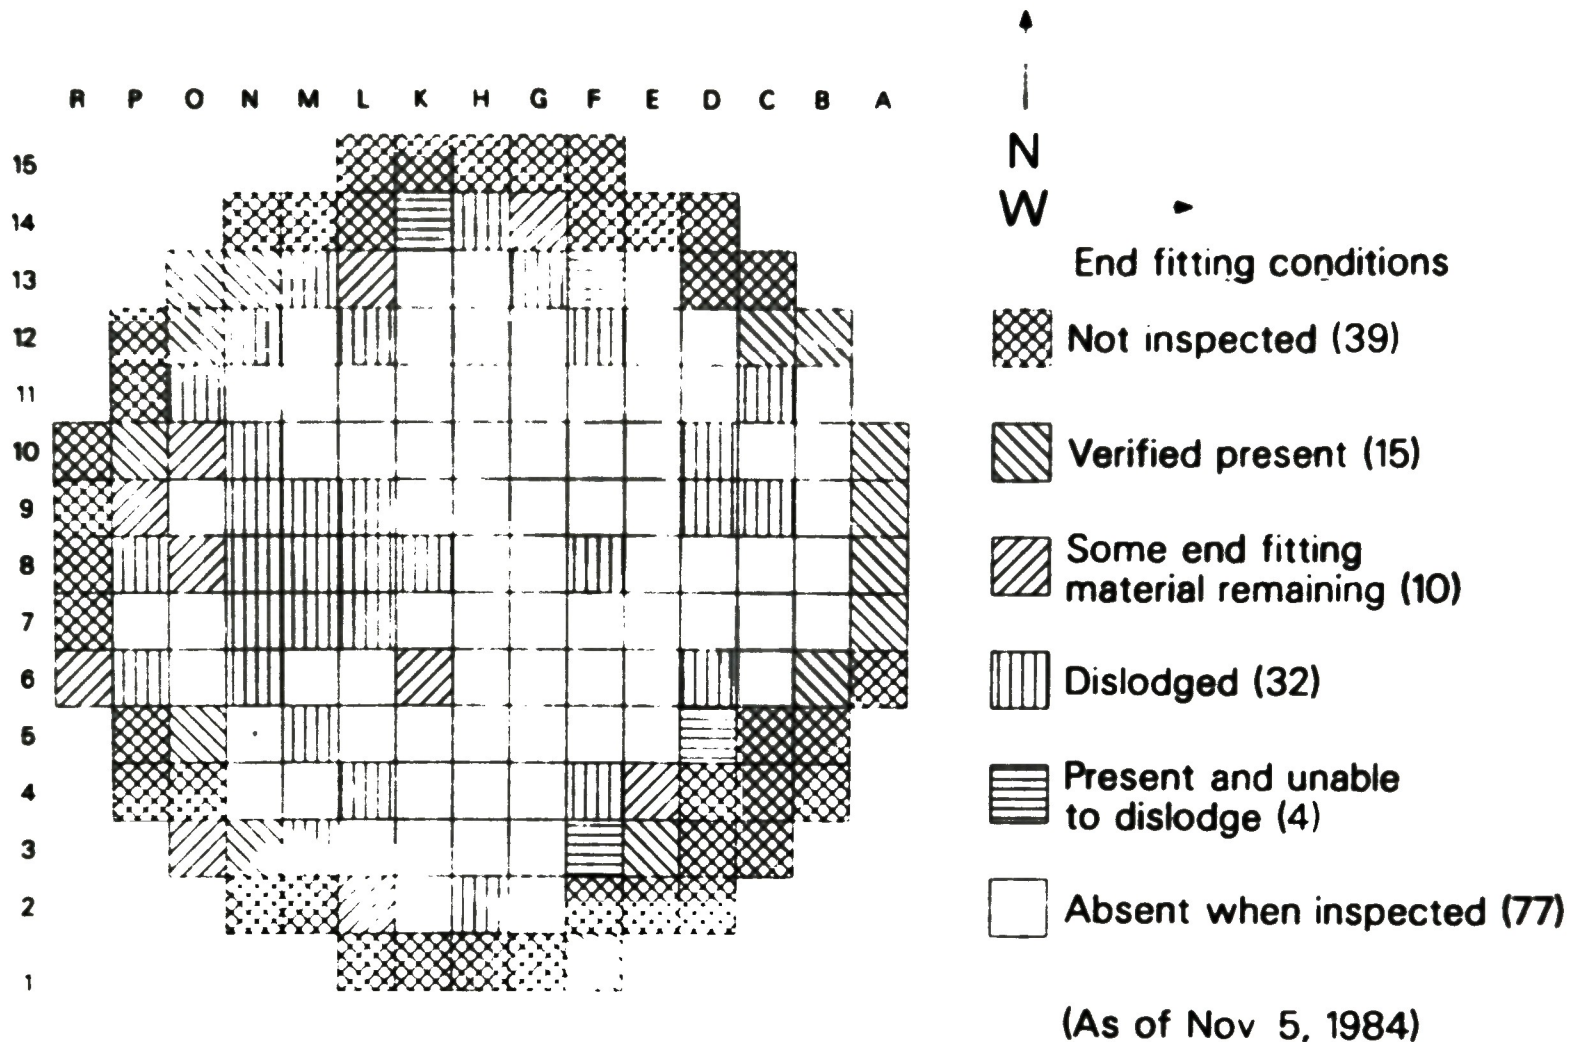
P556 PUI-288-03

With the leadscrews parked within the control rod drives, the reactor vessel head was removed in July 1984. Attempts were then made to dislodge any end fitting that was attached to the underside of the plenum assembly. Such efforts, together with video inspections, yielded the status of the upper end fittings in relation to the plenum assembly. This is shown in Figure 9.⁷ The categories "not inspected" and "verified present" represent those end fittings that were still attached to standing fuel assemblies. These generally were located at the periphery of the core where comparatively little damage to the assemblies occurred. The category under "dislodged" represents those that could easily be knocked

Figure 9. Damage conditions on the underside of the plenum assembly as of November 1984.

off from the plenum assembly by a slide hammer. These were slightly damaged end fittings that were stuck to the upper grid. The categories "some end fitting material remaining" and "present and unable to dislodge" represent those that were partially melted, severely deformed, and probably were welded to the upper grid during the accident. The category "absent when inspected" represents those grid positions that had no end fitting attached to them. In general, the conditions shown in Figure 9 were essentially the same as those shown in Figure 8, indicating that the configuration was fairly stable and represented the end-state damage from the accident in 1979. Any minor discrepancies may have been caused by the difficulties of the observations and the independent judgments of the observers.

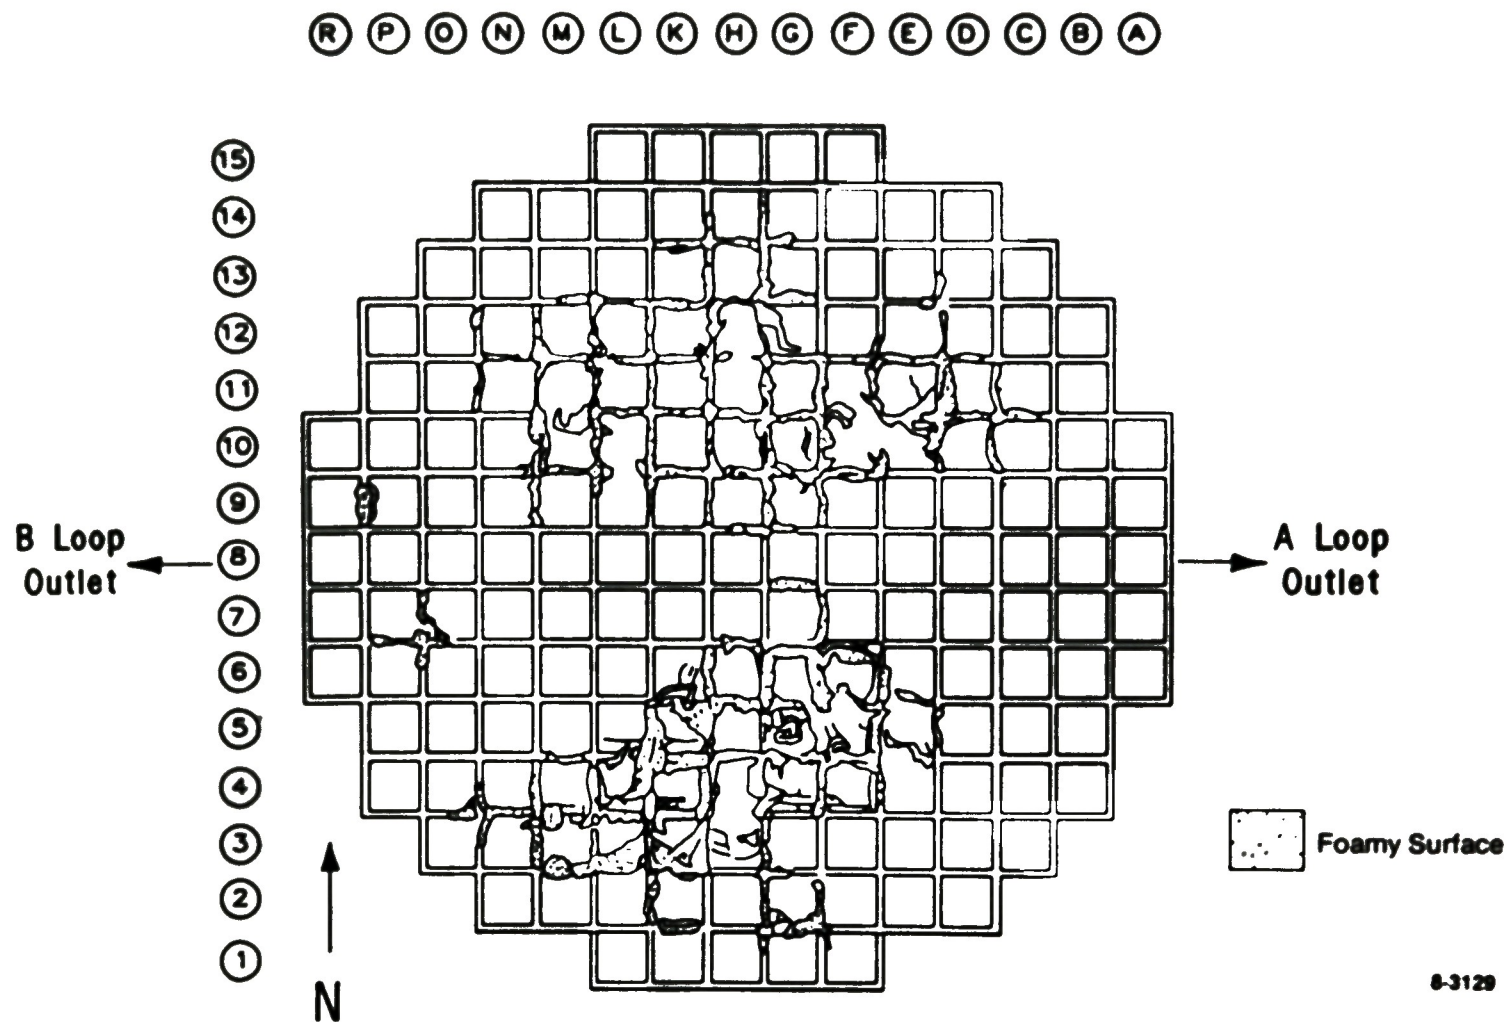
A full view of the damage to the underside of the plenum assembly was not obtained until the plenum assembly was lifted from the reactor vessel on May 15, 1985. Video monitoring was conducted during the removal process and the information stored on a GPUN video tape labeled "Plenum Lift Entry No. 613, May 15, 1985." No discernible damage was observed at the top of the plenum assembly and around the plenum cylinder. The underside of the upper grid, however, showed considerable damage. The damage pattern is shown in Figure 10.⁸

The most striking feature of the damage to the underside of the upper grid is the existence of two distinct damage zones at mid-radius locations in the north and south halves of the cross section. As shown in Figure 11, these are precisely the two zones where the upper end fittings were missing during earlier observations. Within the damage zones, some melting of the upper grid pads is evident. In a few places, such as the boundary between the H11 and H12 grid positions, the ribs are missing, apparently having been melted away. At most positions within the damage zones, the structures inside the control rod guide assemblies also were missing and apparently melted away. In most places, however, the grid structure remains clearly recognizable. The appearance of the damaged structures is extremely nonuniform. Some show ablation at the edges, making the damaged ribs thinner than the undamaged ones, but most of the

Figure 10. Damage pattern on the underside of the plenum assembly.

remains of the damaged ribs show dimensional growth and loss of original geometry, caused by either foaming oxidation or accumulation of previously molten material which had dripped from above.

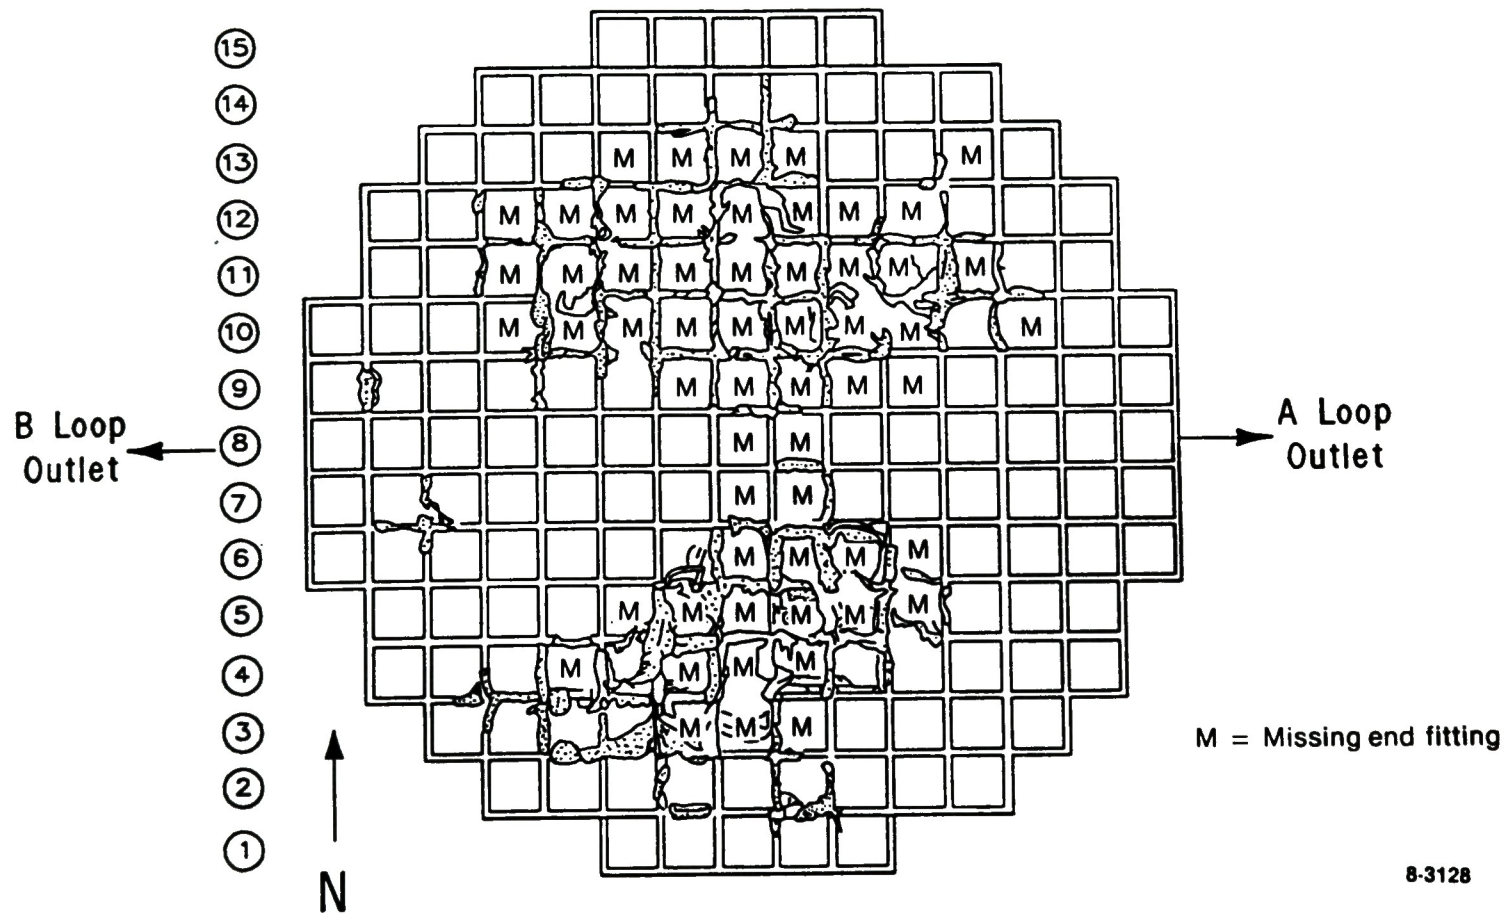
Figure 11. Locations of missing upper end fittings on the underside of the plenum assembly.

For all three calculations, the tables show that the upper end fittings are melted within 30 s. This is consistent with the observation that almost all of the upper end fittings associated with damaged grids were missing at the end of the accident. (The locations of the missing upper end fittings are shown superposed on the damaged grid positions in Figure 11.) The end fittings could have fallen off when the fuel assemblies collapsed, instead of being melted away. However, the presence of other end fittings still attached to the upper grid prior to the partial lifting of the plenum assembly in December 1984, would indicate that at least some of the end fittings associated with the damaged grid positions must have stuck between the ribs and were later melted away.

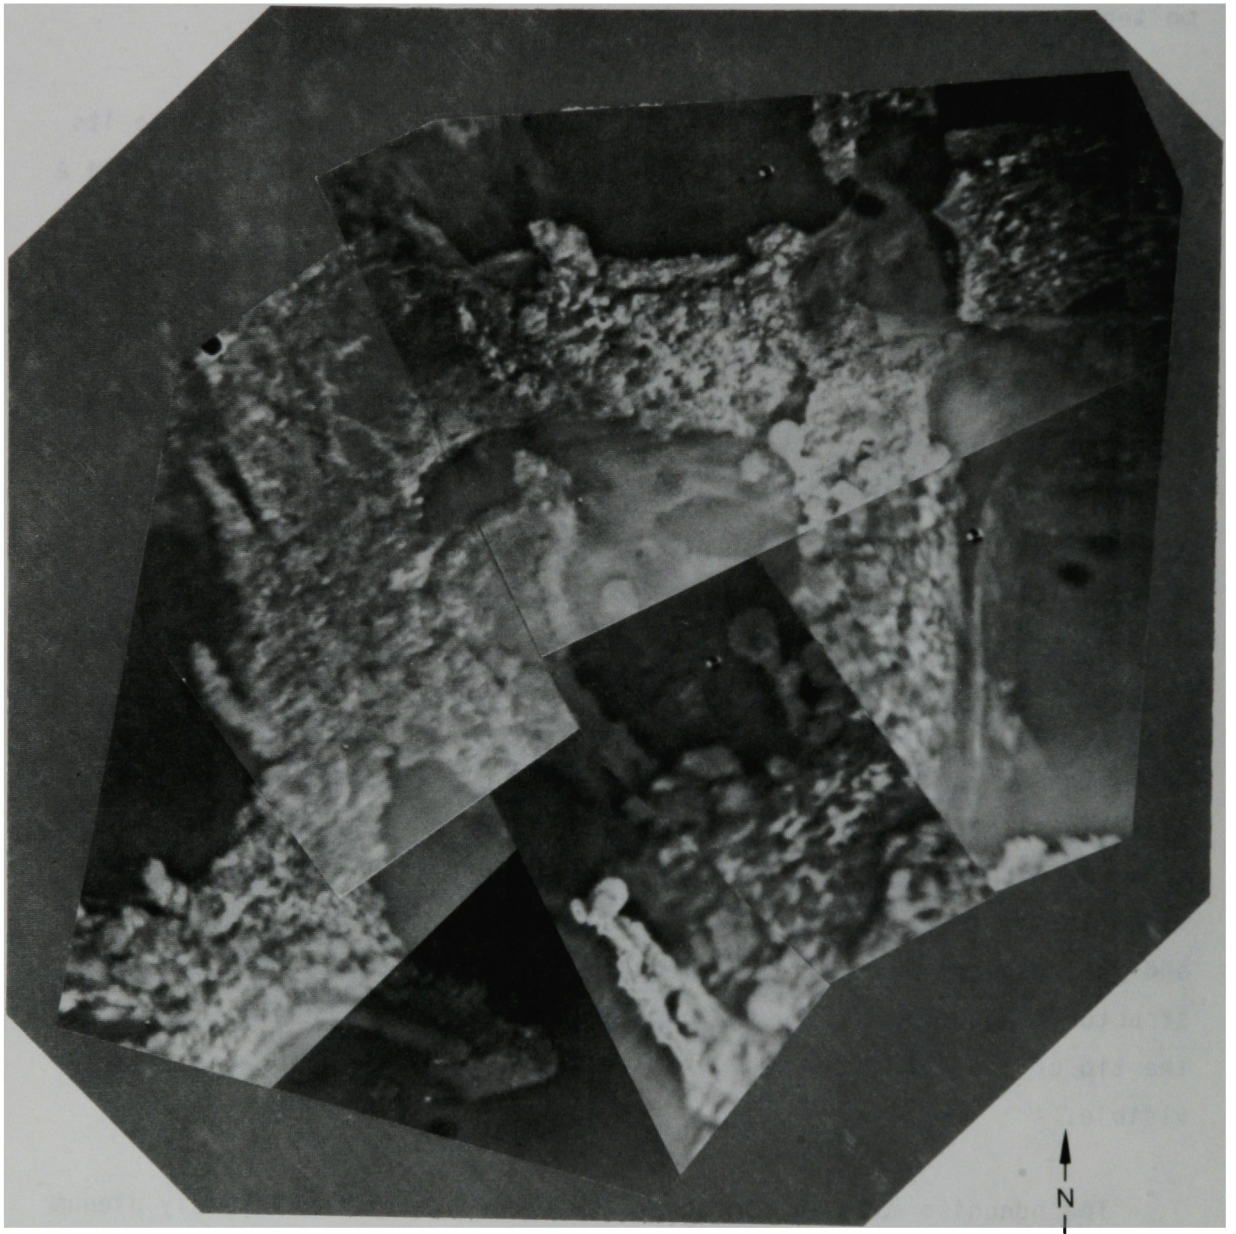
The damage characteristics can change abruptly from one rib to its nearby neighbor. One rib could be severely deformed or missing, while a nearby rib could have suffered only minor ablation. One rib could be extremely foamy, porous, and apparently highly oxidized, while another could be glazed with a layer of solidified melt. At the transition between the damaged and the undamaged zones, the contrast can be quite startling. At positions where the partially damaged end fittings were stuck to the upper grid, some of the thin structures appear foamy or to have been melted, while other equally thin or thinner structures a few inches away remain intact. Similar nonuniformity in damage exists in the upper grid. For example, the rib between the L10 and L9 positions is missing (apparently melted away), while the structures at the L8 position have no discernible damage. A second example is the K9 position. Its rib pads toward the damaged zone to the north are very foamy in appearance, while the structures inside the control rod guide assembly were only slightly ablated. Away from the damage zone, the adjacent K8 position has no discernible damage. Montages of the L10 and K9 positions, made from video images taken before leadscrew removal, are shown in Figures 12 and 13, respectively. Both are control positions. Note that the guide structures above the L10 position appear to be mostly melted, including the tip of the leadscrew, while those above the K9 position are clearly visible.

Figure 12. Damaged grid and guide structures over core position L10. Note the evidence of damage by foaming oxidation (irregular foamy appearance), melting (elongated frozen drops), and ablation (missing rib along south side), as well as the melting of guide structures above the grid.

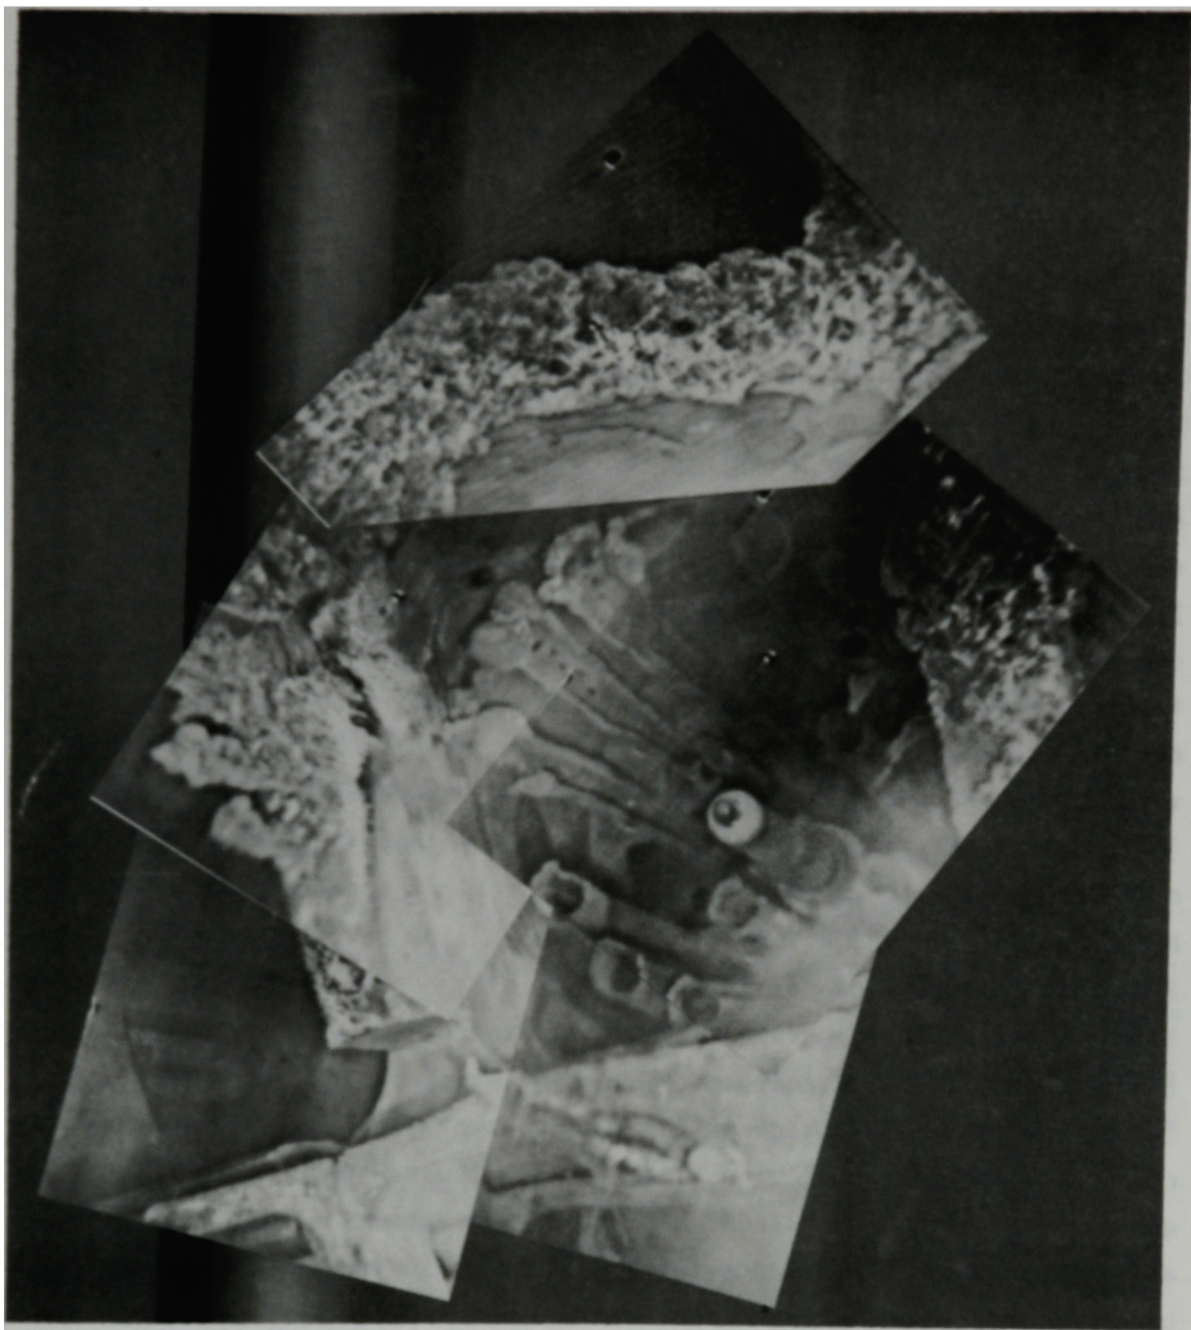
Figure 13. Damaged grid structures over core position K9. While damage types are similar to those in Figure 12, the grid structures above the grid remain largely intact.

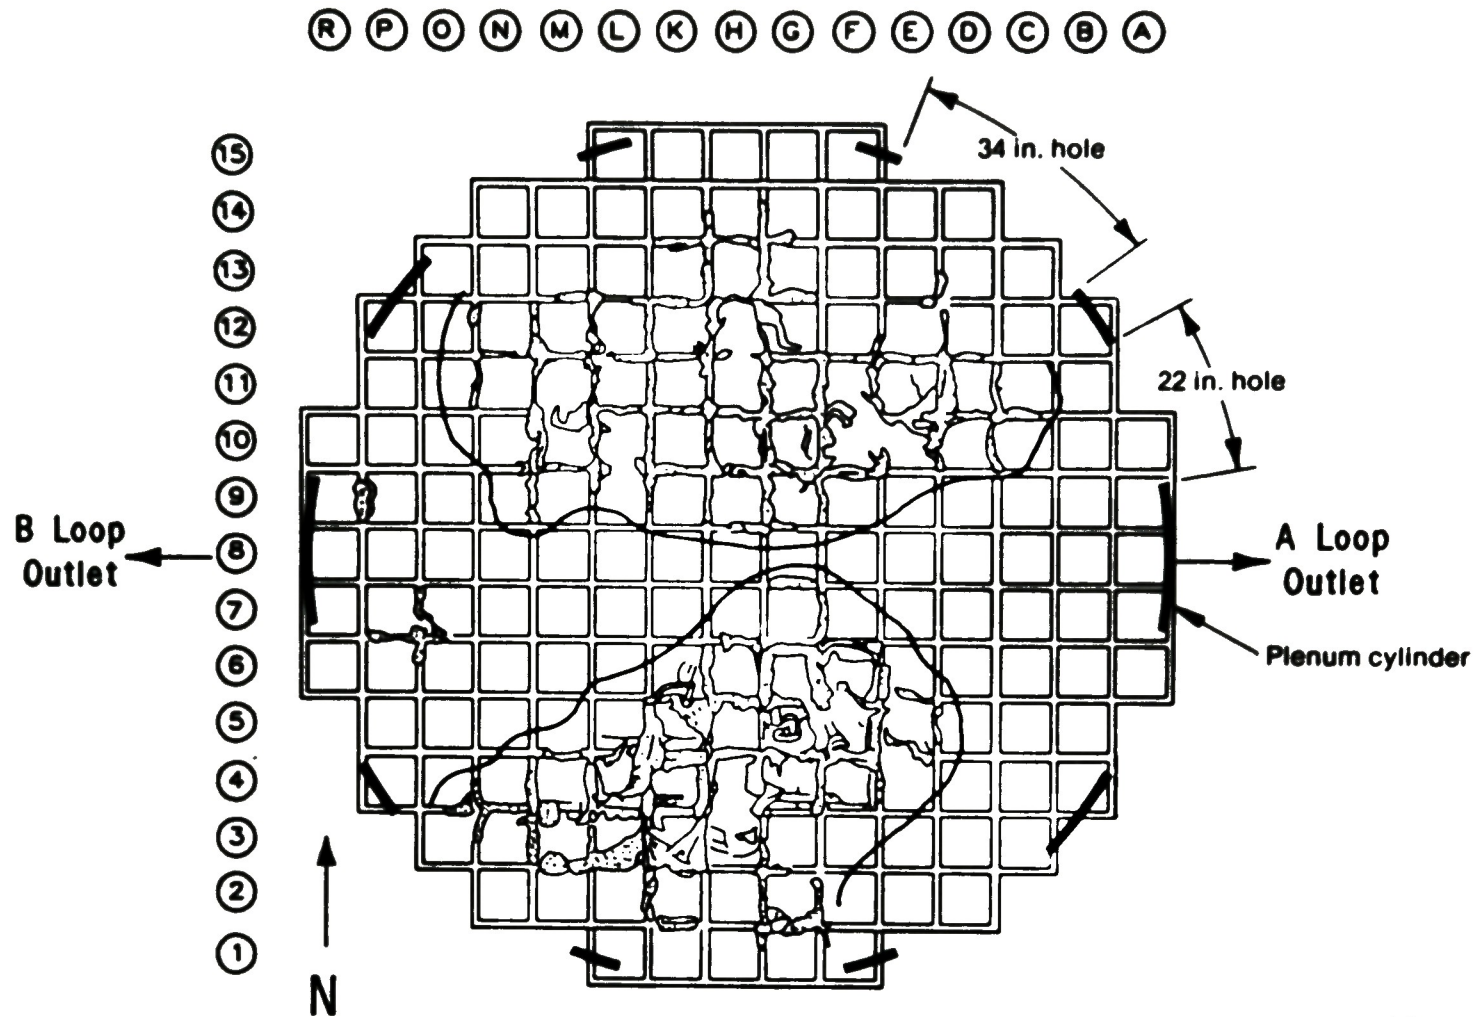
8-3127

Multi-dimensional flow calculations have not been carried out to determine the upper plenum flow pattern. Thus, there has been no quantitative demonstration of the bifurcation of flow from the core to the upper plenum. However, based on the design of flow paths in the upper plenum, an explanation of the bifurcation may be offered. Figure 14 shows the azimuthal position of the main flow holes in the plenum cylinder superposed on the damage pattern in the underside of the upper grid. Instead of directly exiting the outlet nozzles, most of the flow from the core would rise from the core toward the large flow holes. It then would flow downward and around the outside of the plenum cylinder toward the outlet nozzles. One reason for such a flow path is the persistence of vertical momentum of the flow, making sharp turns toward the nozzles at lower elevations difficult. Another reason is that these flow holes are much larger than the ones at the nozzles, so they can carry more flow. Flow area differences also exist in the main flow holes themselves. There are three 34-inch flow holes in each half of the plenum cylinder situated toward the north and south quadrants, flanked by two 22-inch holes. In the east and west quadrants, no flow holes exist at the same elevation. The asymmetry in the design of the positions of the flow holes may have created two preferential directions of flow toward the north and south quadrants of the upper plenum. During normal operation, the fuel assemblies provide resistance to lateral flow, so the flow to the upper plenum is mostly vertical at the core exit and the flow diversion to the periphery occurs at higher elevations. During the accident, the central fuel assemblies collapsed to form a void in the upper core and, thus, the resistance to lateral flow was removed. It is likely that flow from the center of the core could have split into two streams below the upper grid toward the damaged areas.

Figure 14. Azimuthal locations of main flow holes in the plenum cylinder in relation to plenum assembly damage pattern.
